SUBJ: EPA Asbestos Removal at 226 Crane Street

REMOVAL ACTION STATUS REPORT DAVIDSON ASBESTOS

Property Address: 226 Crane Street, Davidson, Mecklenburg County, North Carolina

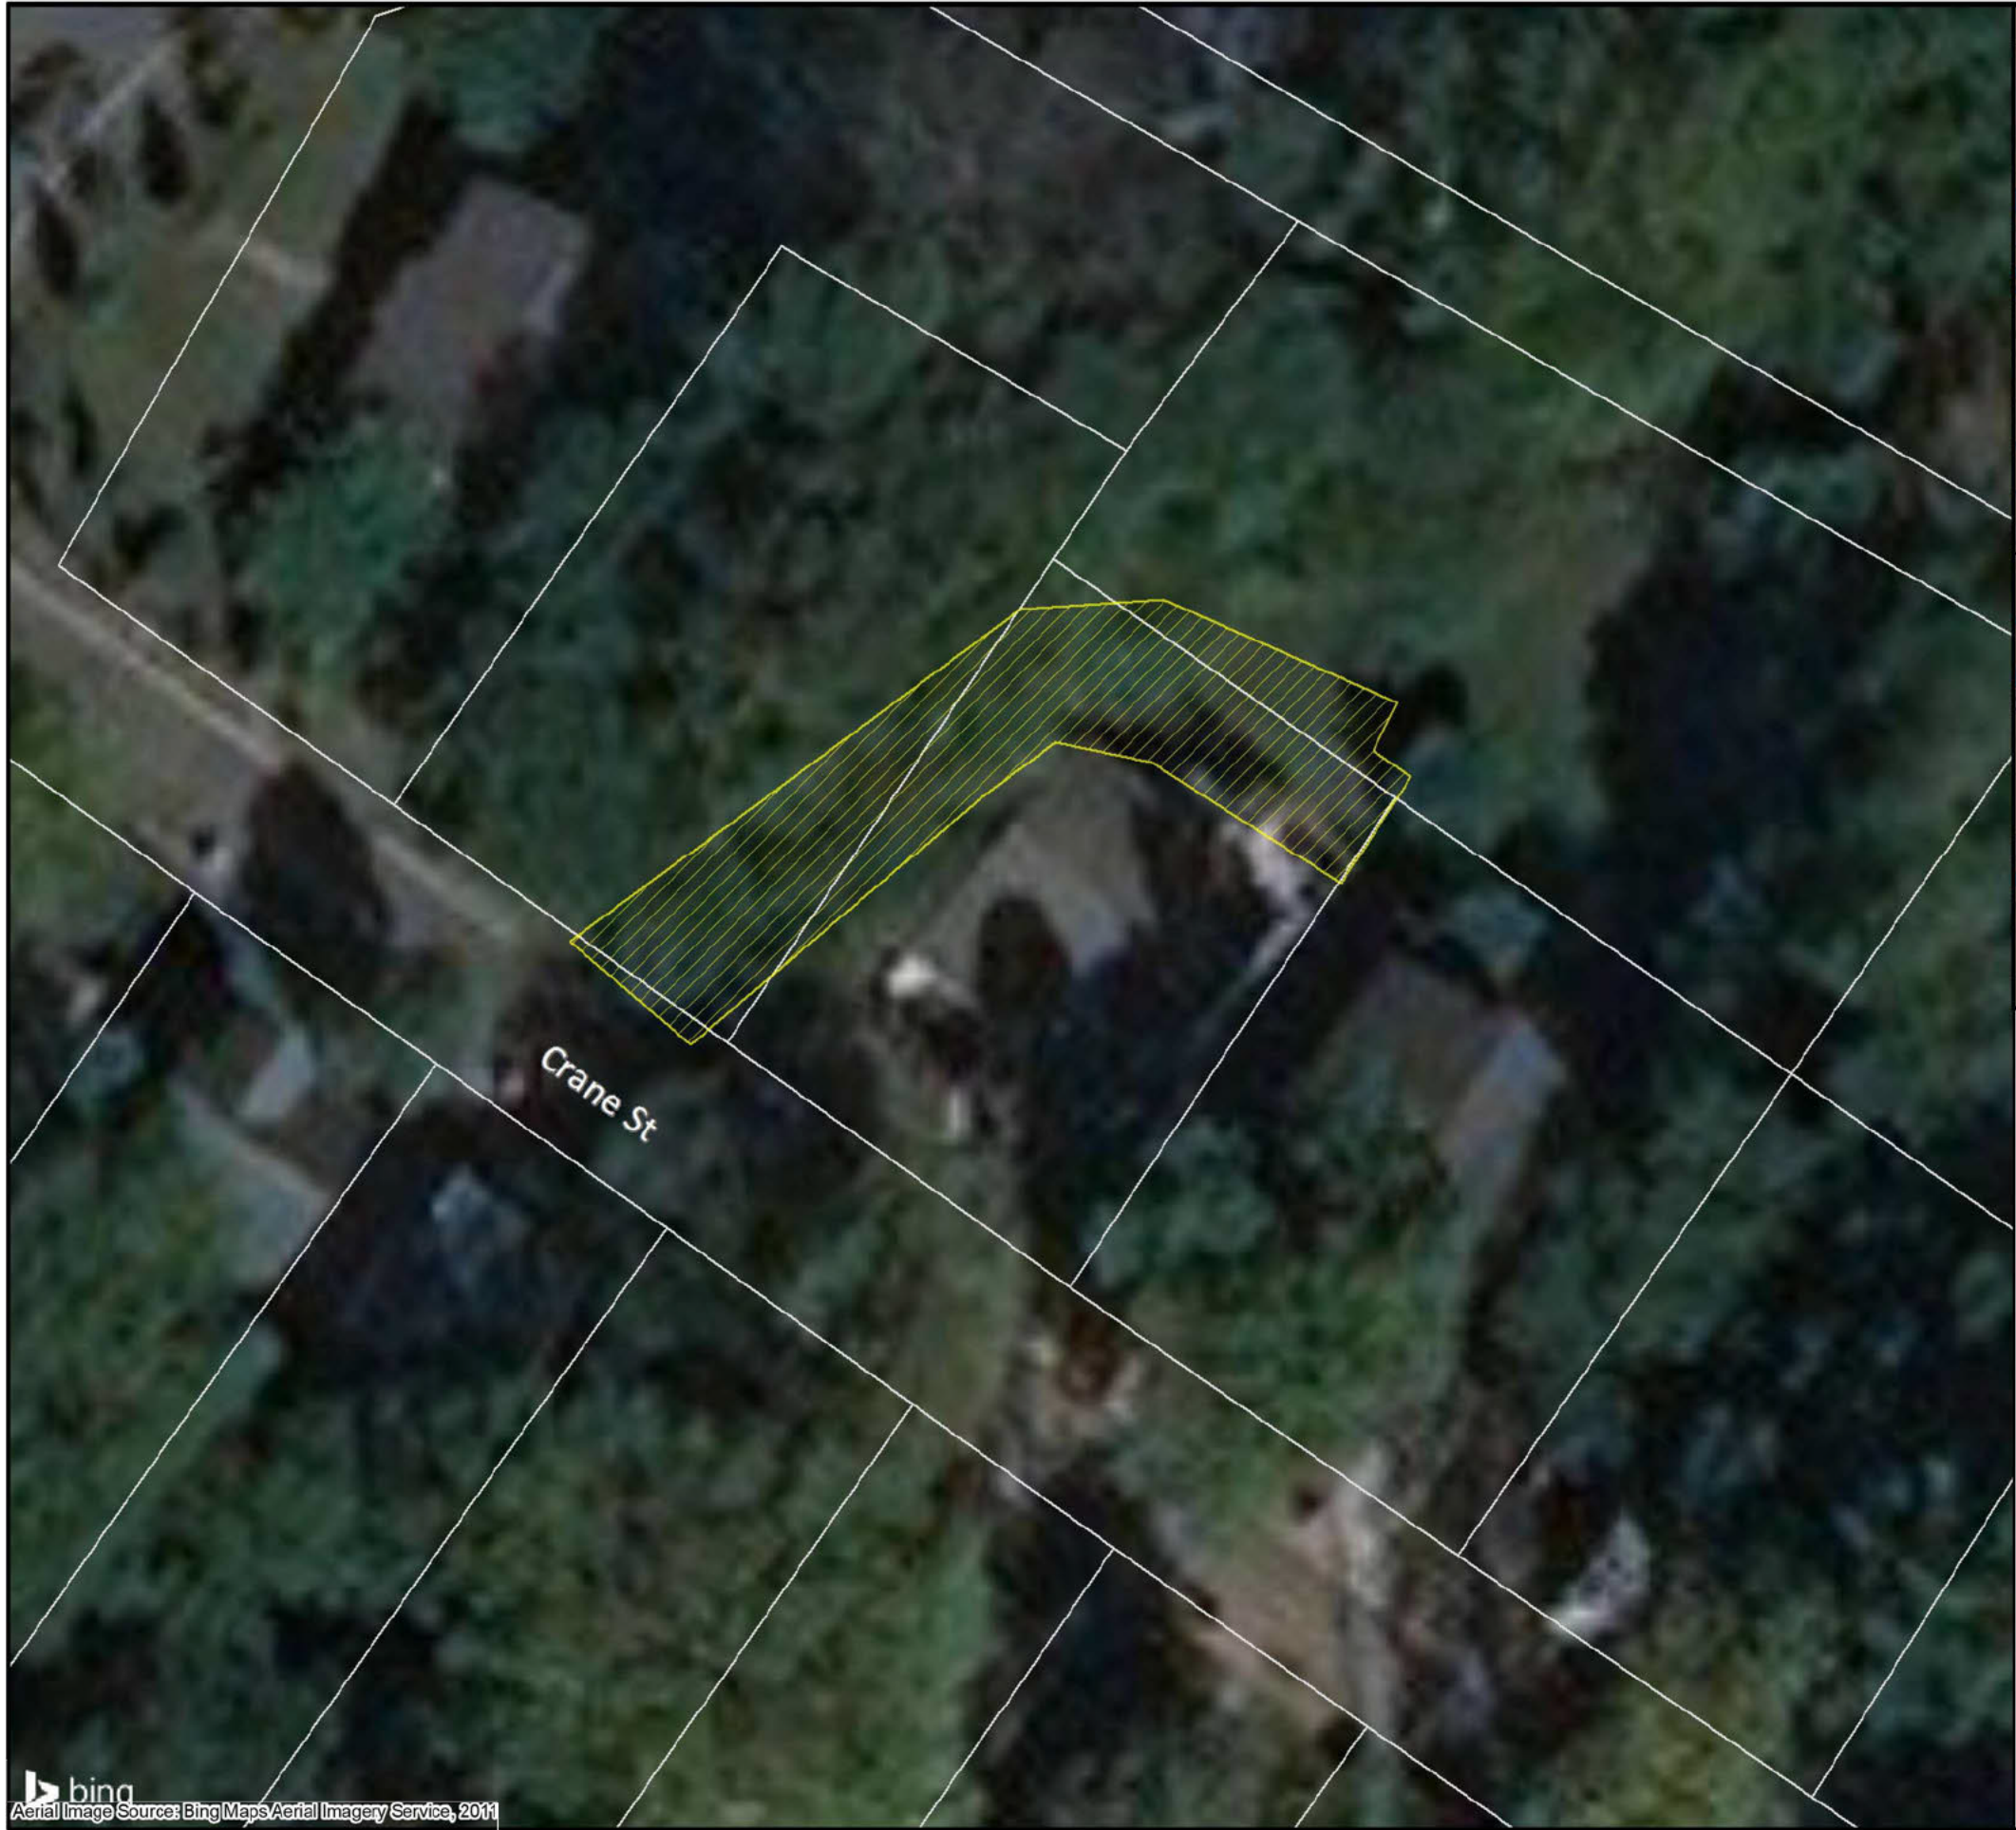
FIGURE 1

Description of Removal Action: The soil was excavated to an approximate maximum depth in the following areas: backyard lawn to 12 inches and along the tree line located on the western side of the residence and the residential drip lines to 3 inches (see Appendix 1). Visual inspections of the excavated areas for asbestos-containing materials (ACM) were conducted by a State of North Carolina-accredited asbestos inspector and air monitor. There were no ACM visibly present in the excavated areas and restoration was allowed to commence.

Restoration of Property: Restoration work included installation of snow fencing on top of the subsurface of the excavated backyard lawn area, backfill, topsoil, and sod in the excavated backyard lawn areas, topsoil, and along the tree line on the western side of the residence. All areas were restored to the original height of the surrounding grade.

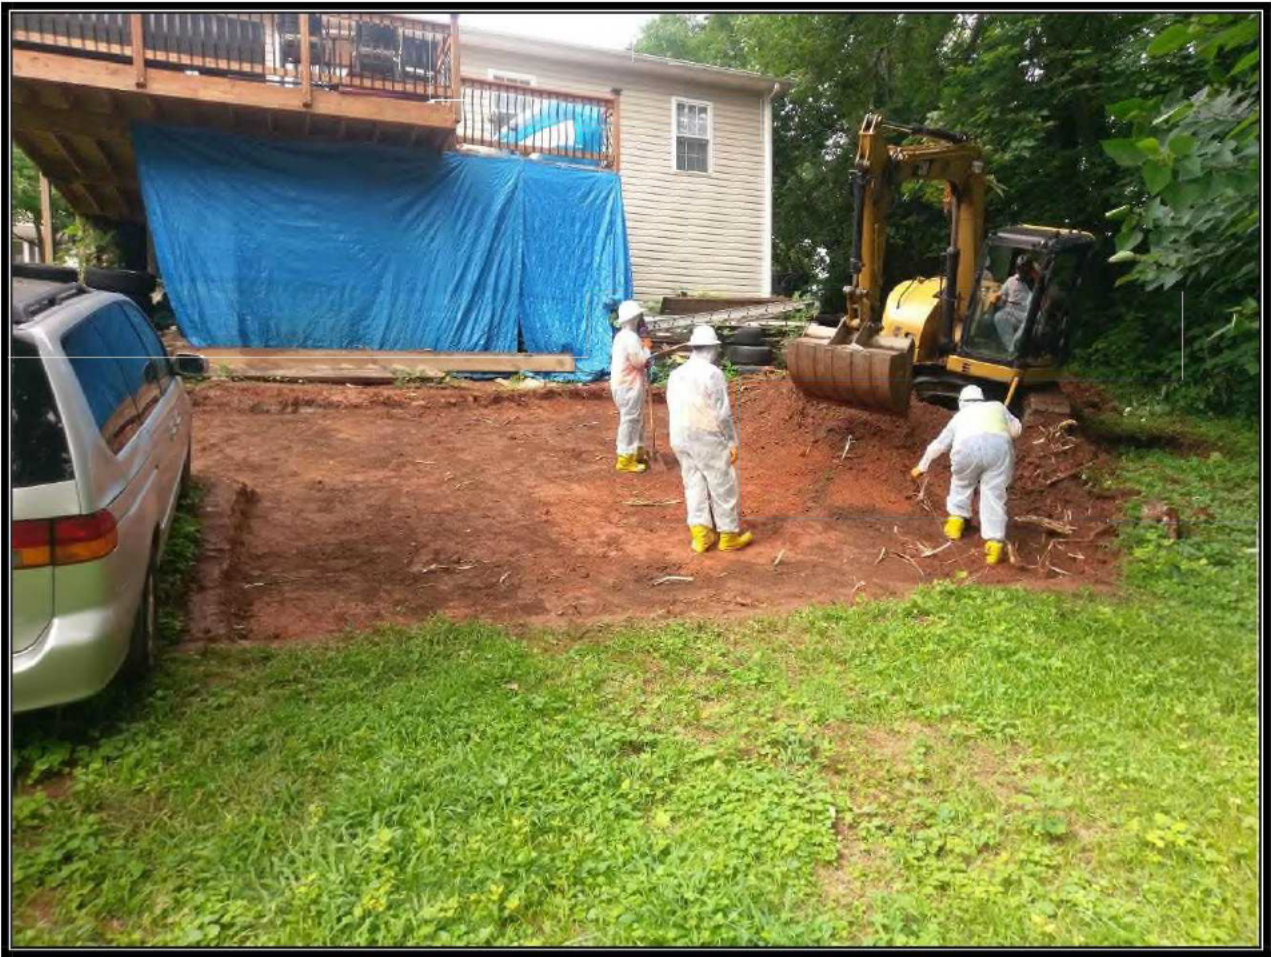
OFFICIAL PHOTOGRAPH NO. 1
U.S. ENVIRONMENTAL PROTECTION AGENCY

Subject: The Emergency and Rapid Response Services (ERRS) contractor, Environmental Restoration, LLC (ER), used an excavator and hand tools to remove asbestos-containing materials (ACM) and asbestos-contaminated soil from the backyard lawn located at 226 Crane Street. ER used hoses to wet the asbestos-contaminated soil during removal activities.

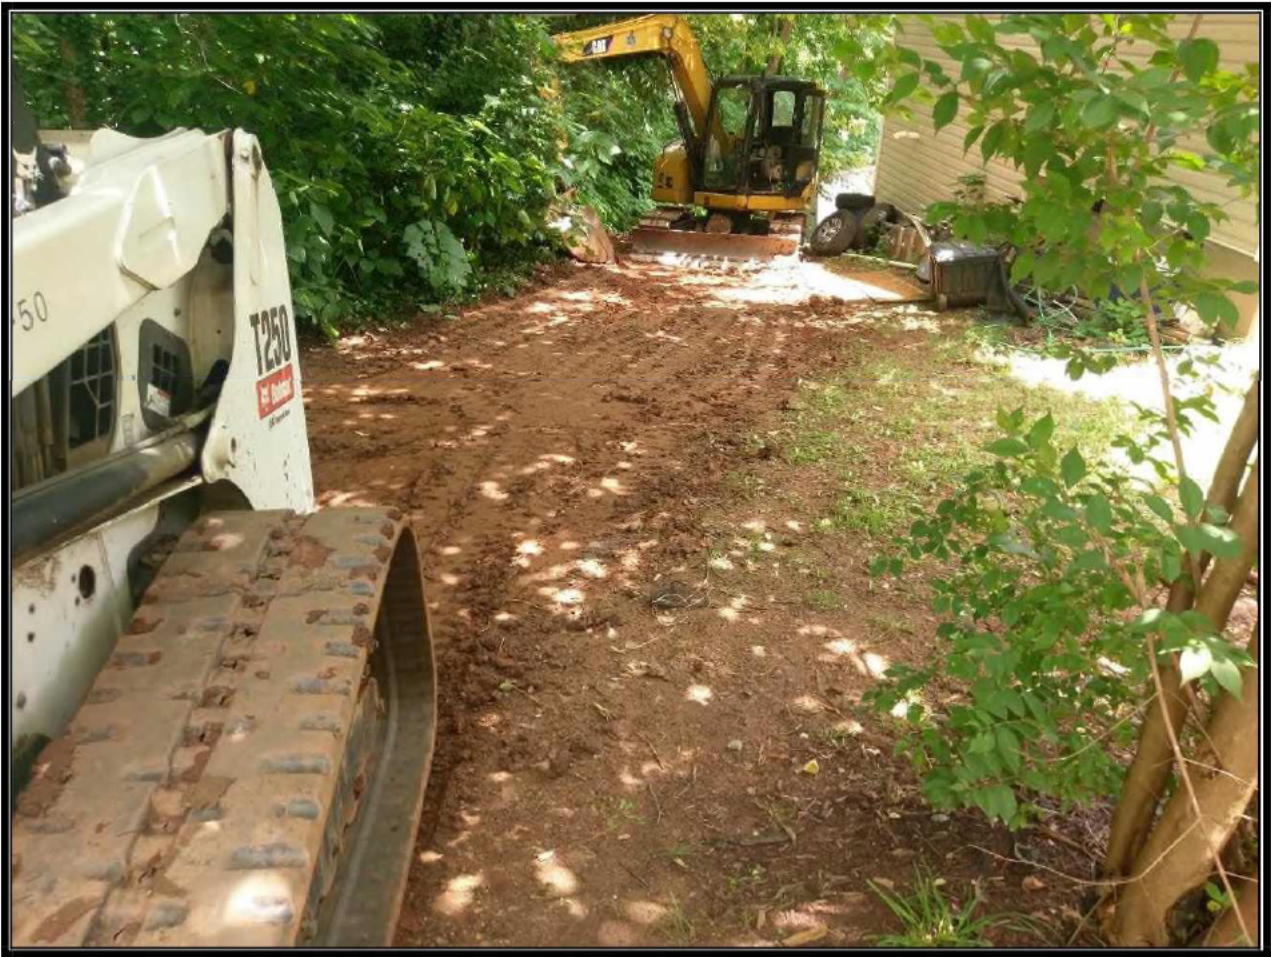
OFFICIAL PHOTOGRAPH NO. 2
U.S. ENVIRONMENTAL PROTECTION AGENCY

Subject: ER used an excavator and hand tools to remove ACM and asbestos-contaminated soil from the tree line area located on the western side of 226 Crane Street. ER used hoses to wet the asbestos-contaminated soil during removal activities.

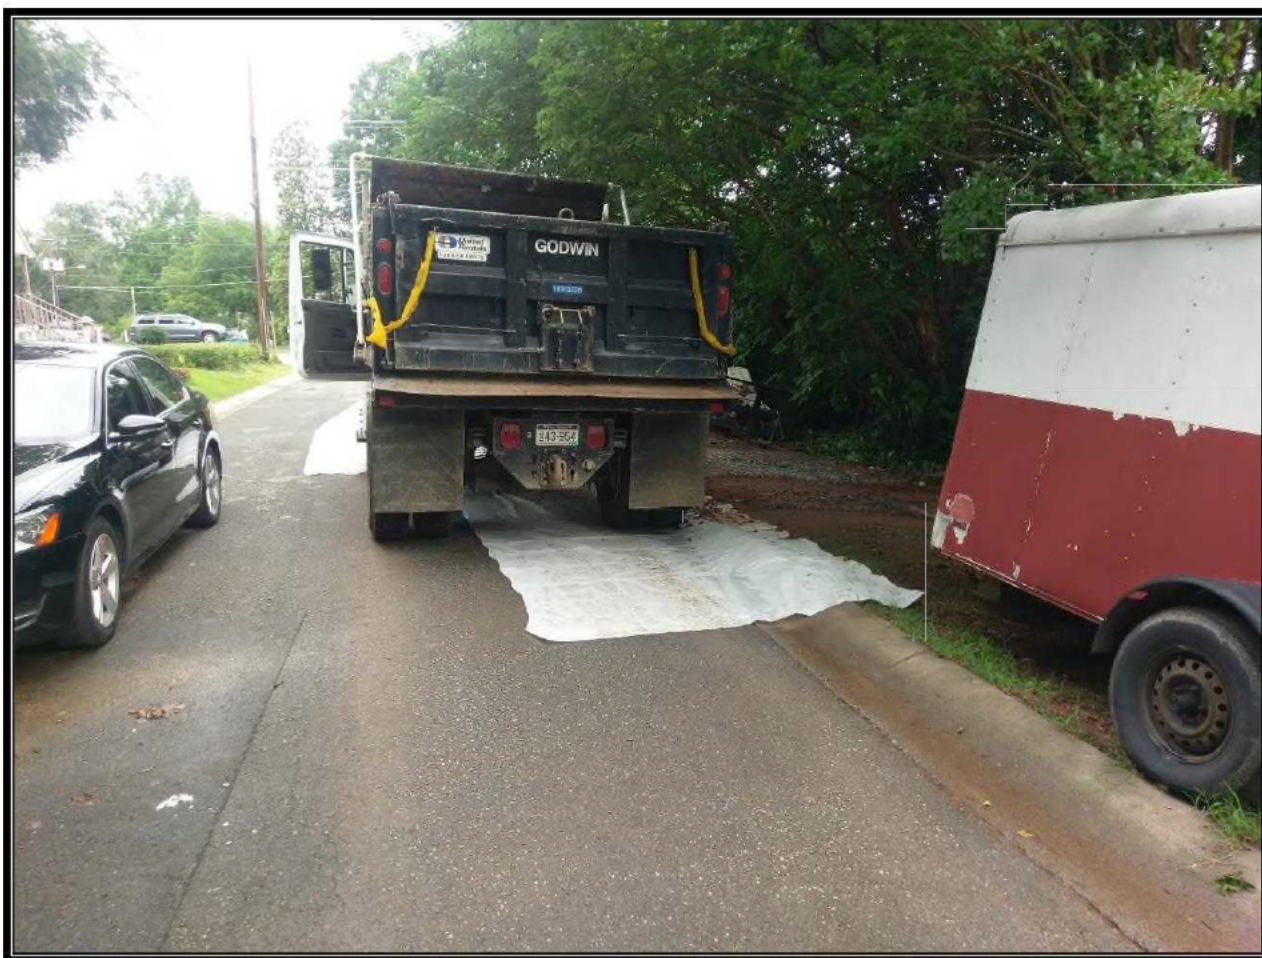
OFFICIAL PHOTOGRAPH NO. 3
U.S. ENVIRONMENTAL PROTECTION AGENCY

Subject: ER placed plastic sheeting under the dump trucks to prevent asbestos-contaminated soil from falling onto the road during removal activities.

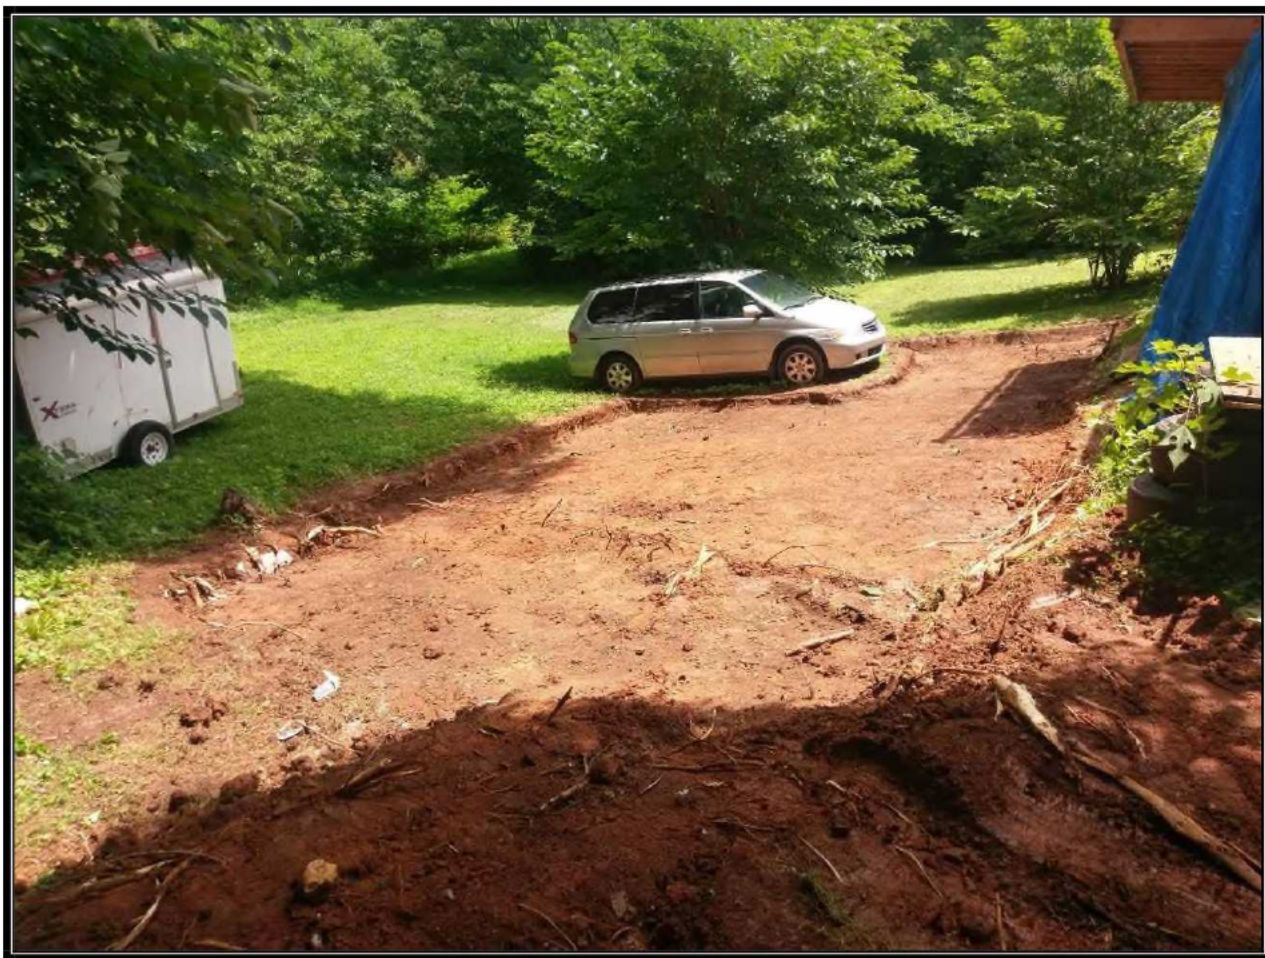
OFFICIAL PHOTOGRAPH NO. 4
U.S. ENVIRONMENTAL PROTECTION AGENCY

Subject: Tetra Tech Superfund Technical Assessment and Response Team (START), State of North Carolina-accredited asbestos inspector and air monitor, visually inspected the excavated areas for the presence of visible ACM. Since no visible ACM was detected in the excavated areas, restoration was allowed to commence.

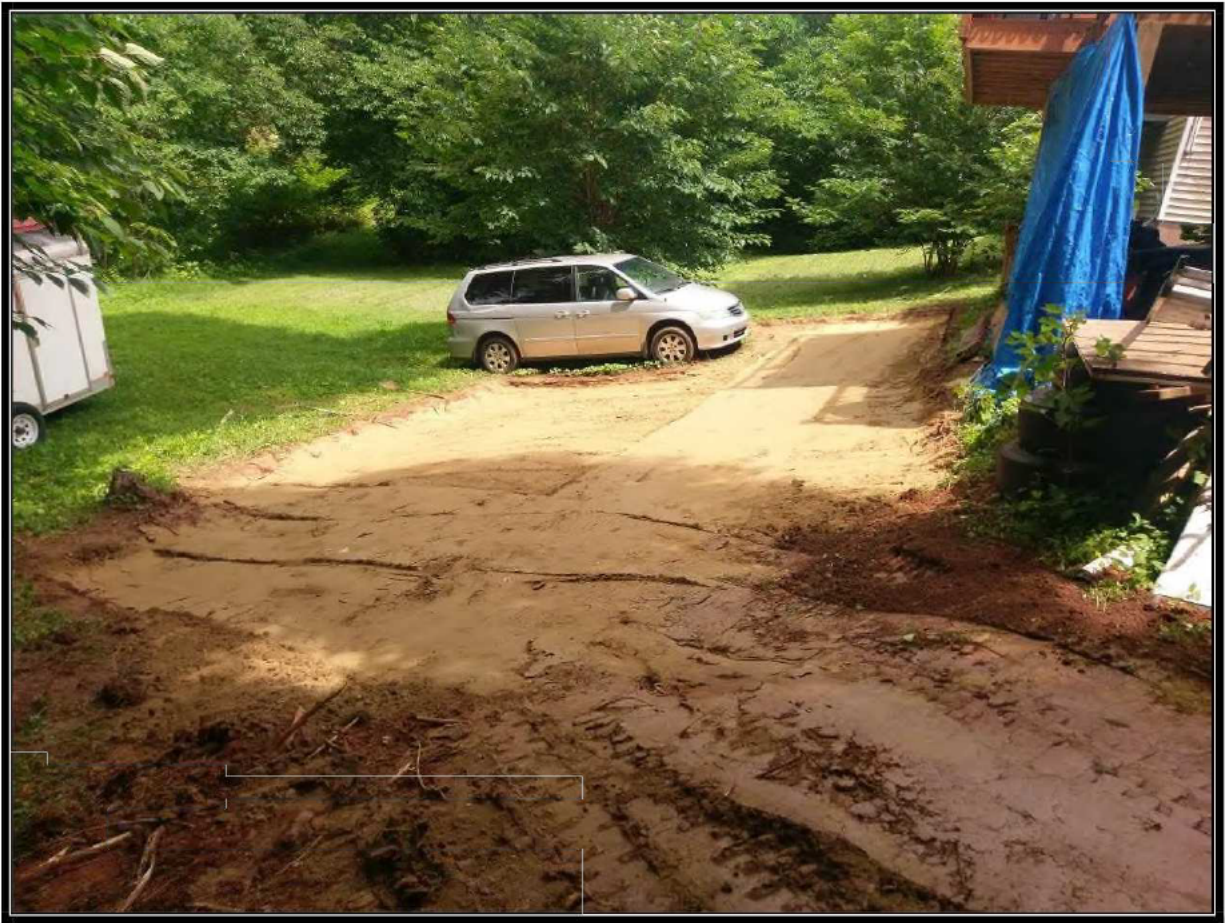
OFFICIAL PHOTOGRAPH NO. 5
U.S. ENVIRONMENTAL PROTECTION AGENCY

Subject: ER installed snow fencing along the subsurface of the excavated backyard lawn and backfill using dump trucks and a skid steer after the visual inspection conducted by Tetra Tech START, State of North Carolina-accredited asbestos inspector and air monitor, detected no visible ACM in the excavated areas.

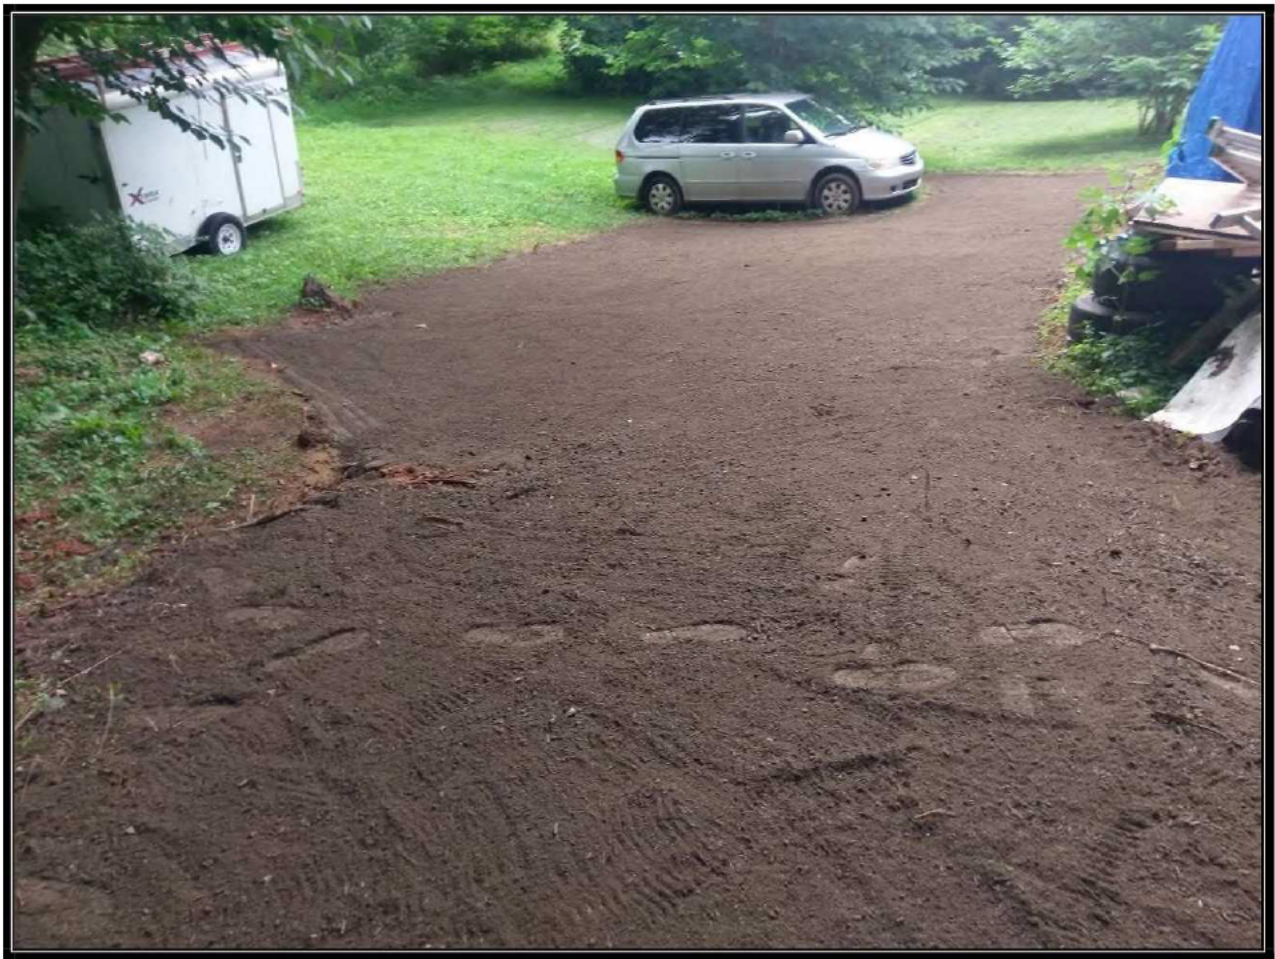
OFFICIAL PHOTOGRAPH NO. 6
U.S. ENVIRONMENTAL PROTECTION AGENCY

Subject: ER used dump trucks, skid steers, and rakes to install topsoil in the excavated backyard lawn.

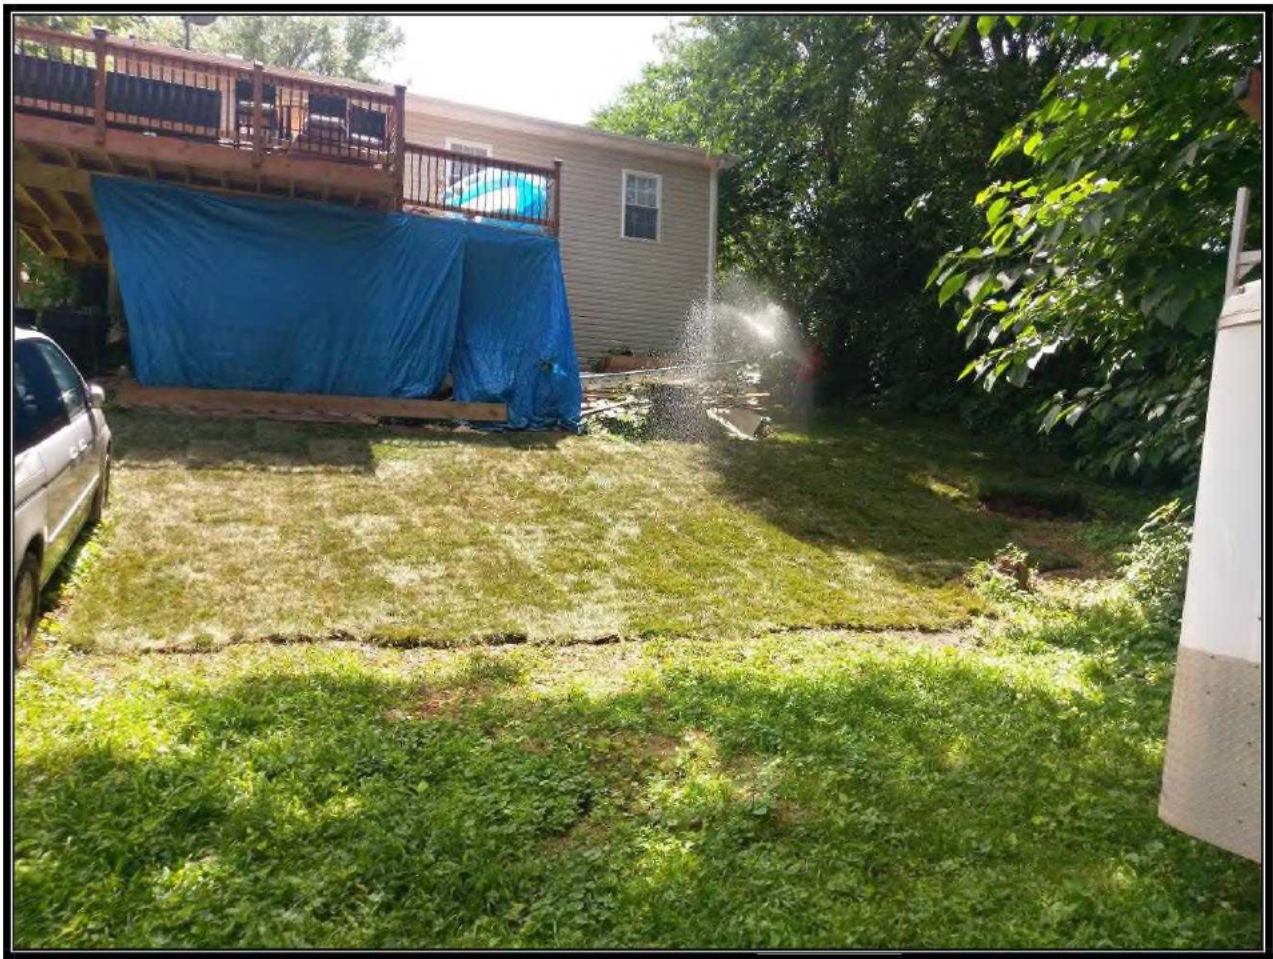
OFFICIAL PHOTOGRAPH NO. 7
U.S. ENVIRONMENTAL PROTECTION AGENCY

Subject: ER installed sod in the excavated backyard lawn and used a water buffalo the water the sod after it was installed.

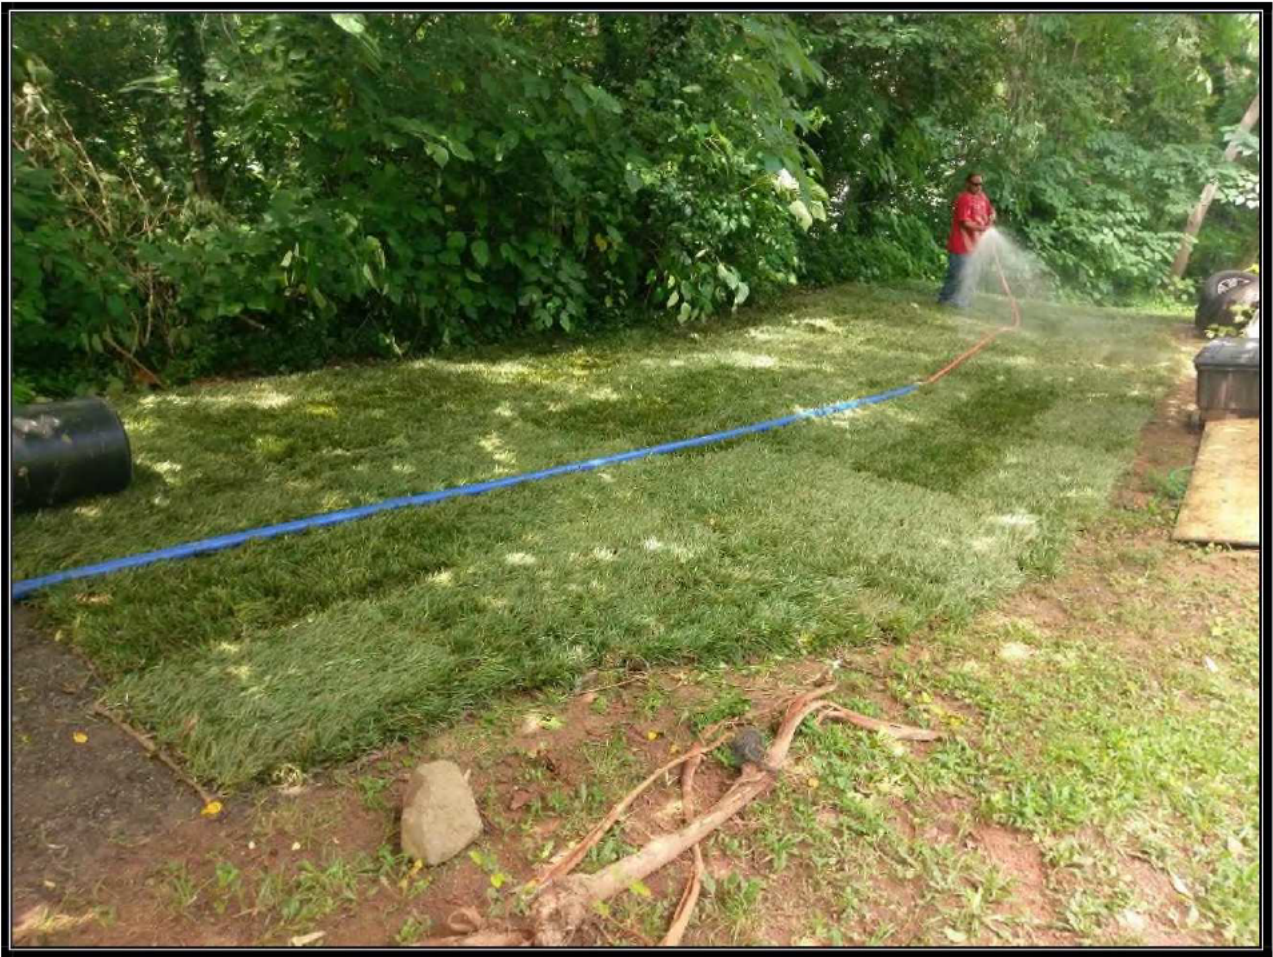
OFFICIAL PHOTOGRAPH NO. 8
U.S. ENVIRONMENTAL PROTECTION AGENCY

Subject: ER installed sod in the excavated tree line area located on the western side of the residence and used a water buffalo the water the sod after it was installed.
